XO 4 & XO FLEX TROUBLE SHOOTING GUIDE

YB-907

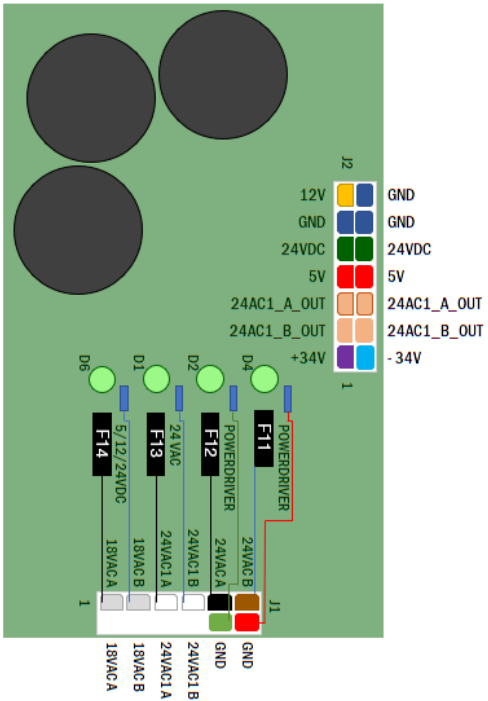
PIN	Volt	Explanations.

1	+34V	LED D2 & D4 indicates ± 34 V is available. ± 34 V is transformed by the “power driver AO-137” placed in the bridge Used for the rotation of the micromotor MC3 and for the functionality of the curing lamp. Check the ± 34 V on the “J1 stand” located on the “Bridge PCB AN-368”
		8	-34V	
		2	24VAC	LED D1 indicates that 24VAC is available. LED D800 located on the “Bridge AN-368” indicates the presence of 24VAC.
		9		
		3	24VAC	
		10		
		4	5VDC	Consult the 5V Surge Protection session on page 17
		11		
		5	24VDC	LED D6 indicates that 24 VDC is available. LED D191 located on the “Bridge PCB AN-368” indicates the presence of 24VDC. The fuse F1 on the “Bridge PCB AN-368” protects the 24VDC on the “Bridge PCB AN-368”.
		12		
		6	GND	0V
		13		
		14		
		7	12V	Available - Not used

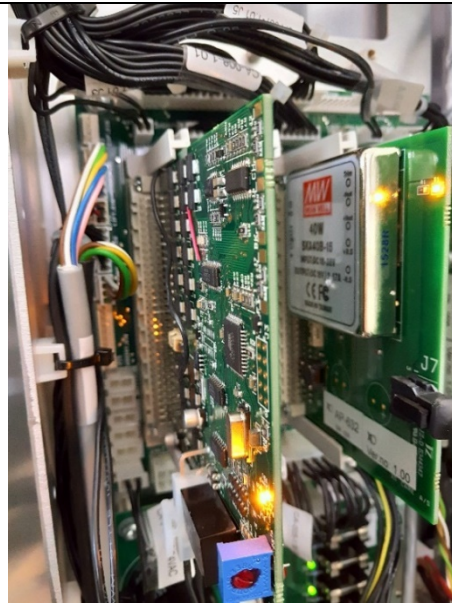
- Can only be positioned in the leftmost position on the Backplane PCB
- Equipped with a fuse F1 (ML-600).
- Yellow LED D29 indicates that 24VDC is available in the unit stand
- Provides power to the LED XO OP Light
- Stand controller PCB firmware can be updated via RS-485 bus

Failure description		Reason	Solution
D29 LED is OFF (24VDC)		Fuse F1 on Stand Controller is blown	Replace fuse F1, 2A Nano type fuse ref. ML-600.
SENSORS		VALVES AND PUMPS	
S5	LEVEL DETECTOR FOR BACKFLOW PREVENTION	V4	CUP FILLER
S5B	LEVEL DETECTOR FOR WATER CLEAN	V7	CUSPIDOR FLUSH
S11B	MIXING CUP LOW LEVEL DETECTOR FOR SUCTION CLEAN	V39	WATER FLUSH / SUCTION CLEAN
S11T	MIXING CUP HIGH LEVEL DETECTOR FOR SUCTION CLEAN	V10	MAIN WATER VALVE
S14	LEVEL DETECTOR FOR WATER CLEAN	V12	MAIN AIR VALVE
S15	LEVEL DETECTOR FOR SUCTION DISINFECTION	V16	SMALL SUCTION Ø11
S33	WATER LEAK SENSOR	V17	LARGE SUCTION Ø16
S37C	CUP FILLER SWITCH	V22	SUCTION CLEAN VALVE
S37F	CUSPIDOR SWITCH	V27	WATER CLEAN
S38	SUCTION CLEAN SWITCH	V30	PRESSURISATION CONTAINER VALVE
S41	CUSPIDOR FLUSH SWITCH	V31	WATER CLEAN PUMP
		V35	SUCTION CLEAN PUMP
<p>Before replacing the “Stand Control AO-891”, always check the fuse F1 state. Check and probe the cables controlling the 24V to detect any short circuits. Below is a list of the faults connected to the “Stand Control PCB AO-891”.</p>

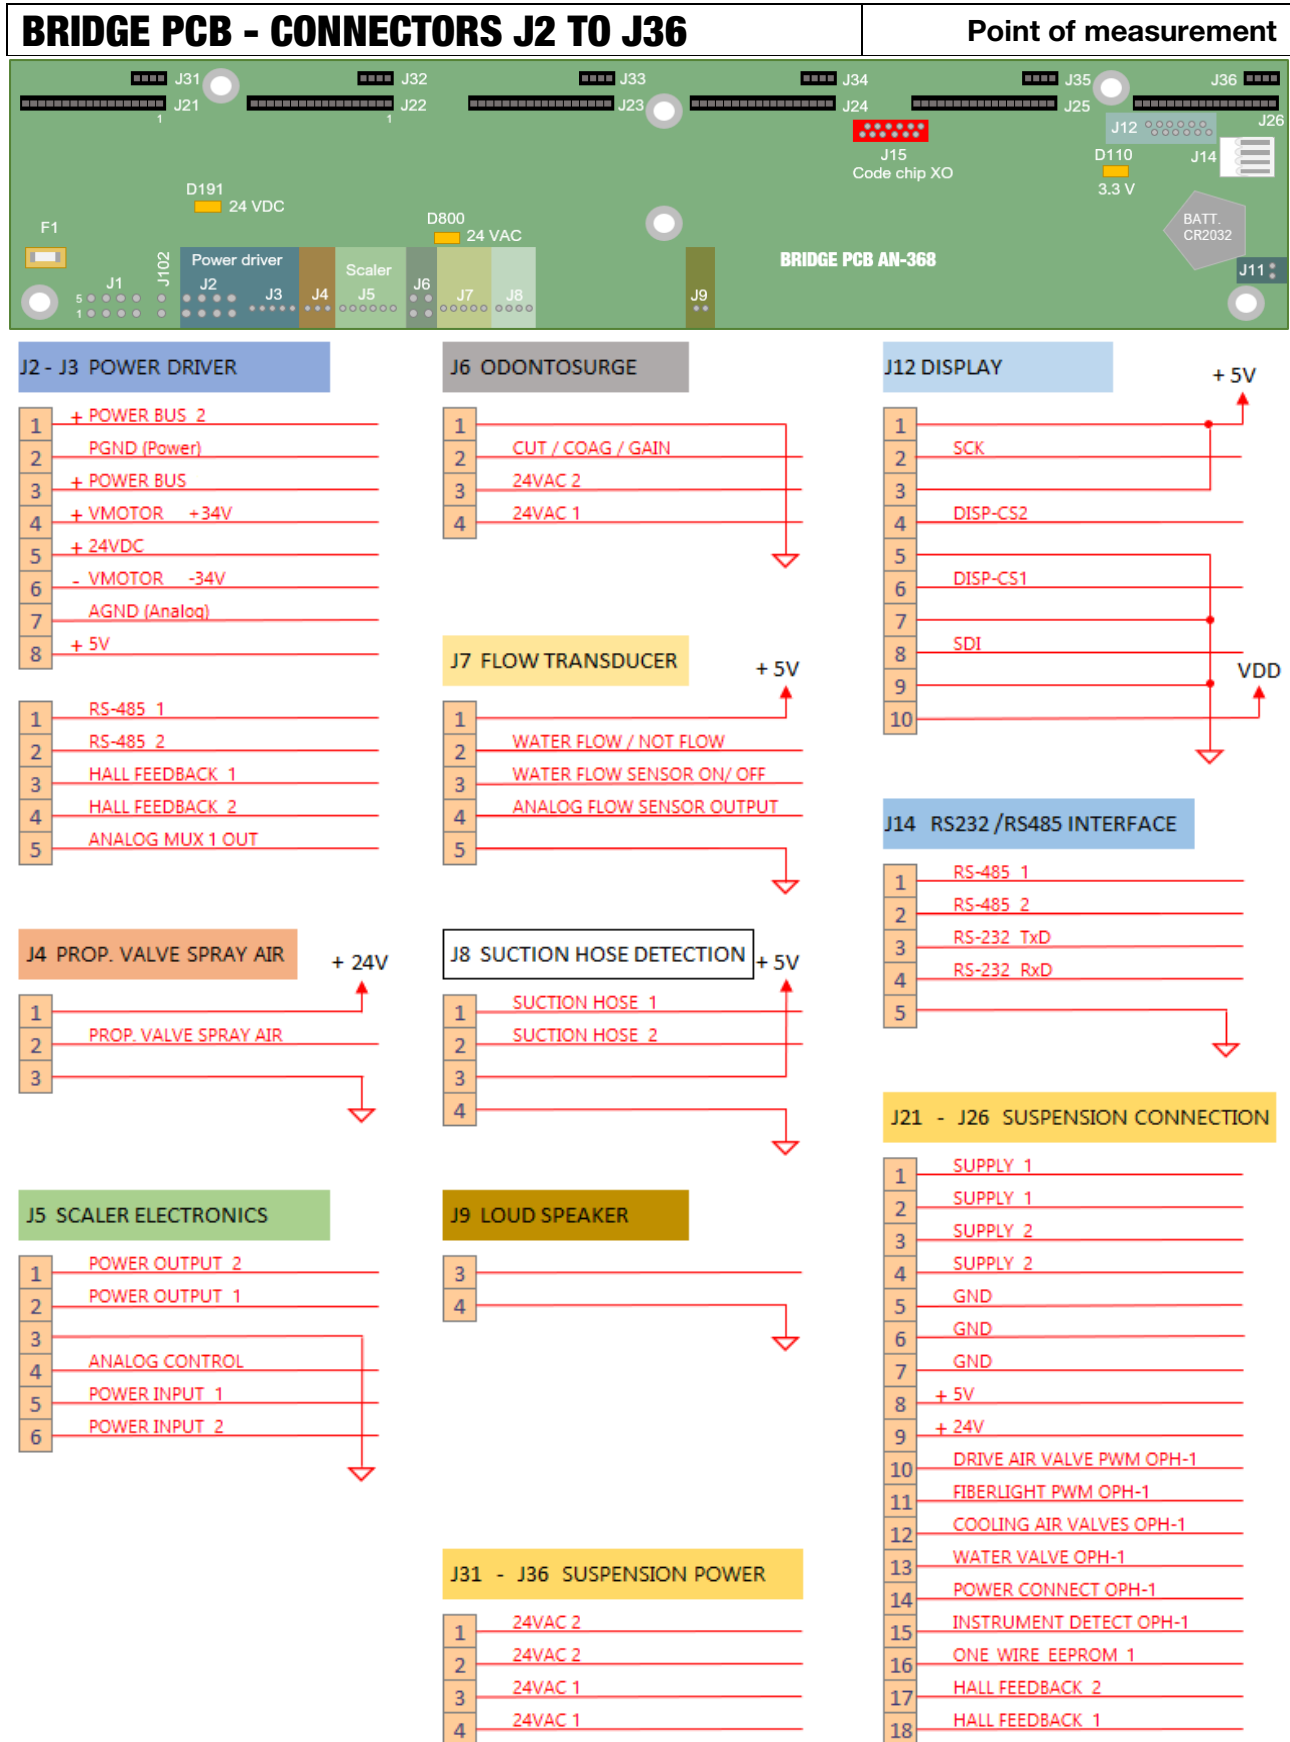
“POWER DRIVER PCB”:																																																																				
Purpose:																																																																				
The “Power driver PCB” is an advanced power supply with its own microprocessor programmed to provide the required power and voltages, generates also the PWM signal to the water proportional valve. Also controls AC motors type OSSEO but not brushless motor type MX2																																																																				
Failure description	Reason	Solution																																																																		
D6 LED is OFF.	Failure on the 5V supply from AN-368	Check the CA-017 Power Driver cable. For voltage measurements on J2, refer to “Jumpers disposition” page 21.																																																																		
	D6 is placed on the opposite side of the PCB. The reflection of LED D6 is visible on the plate as shown in the picture

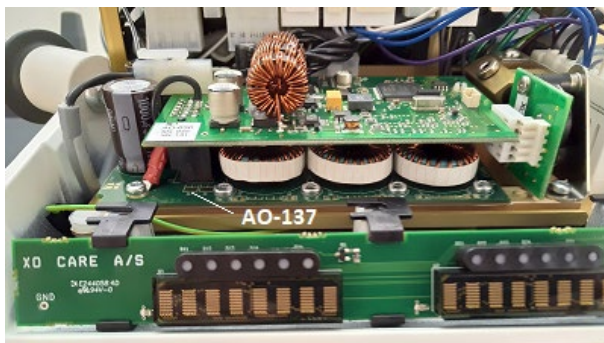
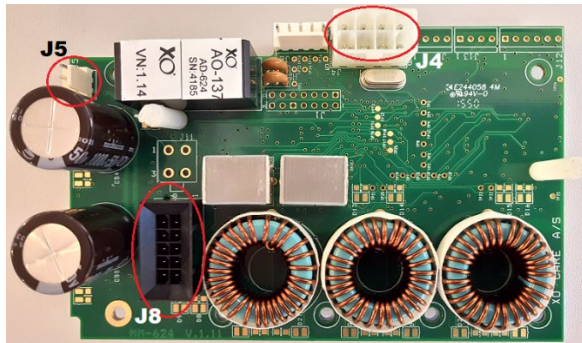
AO-137 PCB in the bridge		AO-137 connections sockets

J4 Connection to J2 on AN368 J5 PWM connection for proportional valve J8 Connection AO-134 PCB MX2 control Board

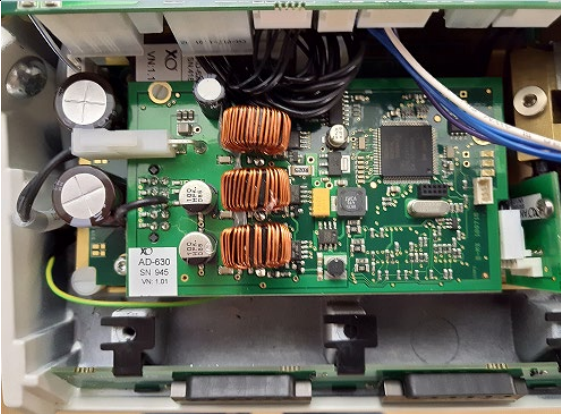
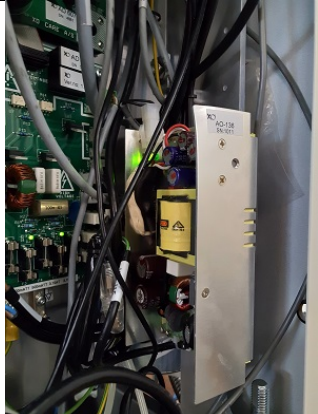
Check that the green LED on the +32V DMX power supply AO-136 is lit.
		If the green LED is on, check that the CA-073 cable is connected correctly.
		If the green LED is off, check that the cable J12 - J15 connecting the DMX motor power supply to the AN-378 hand board is correctly connected.
	The “Power driver” is defective.	If the yellow LED on the DMX control board AO-136 is lit, replace the “Power driver PCB AO-137”.
“DMX AO-134” Porte-instrument		Power Supply DMX AP-944

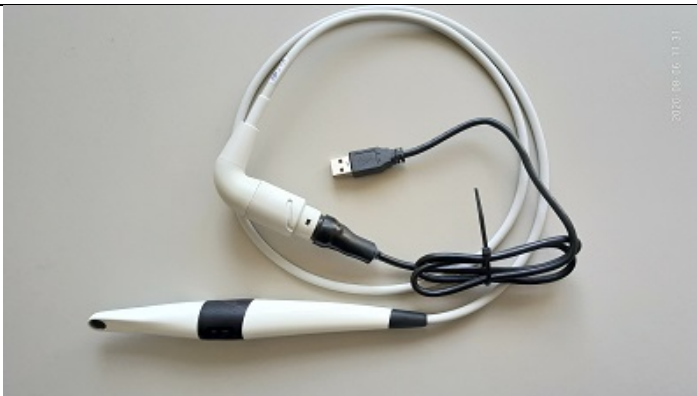
Test cable for Dürr Vistacam	
<p>CA-220: Test cable for Dürr Vistacam IX and IX HD with normal bayonet</p> <p>AO-329 : iX AO-347 : iX HD</p>

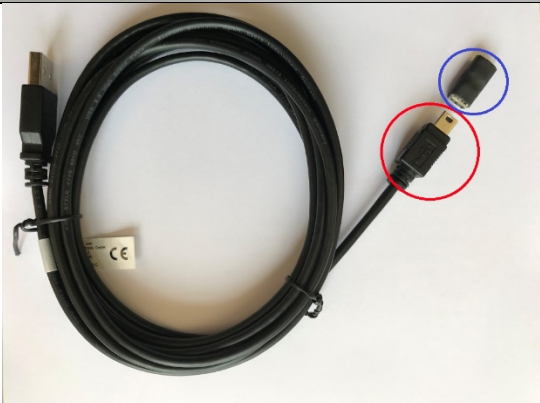
<p>AP-071 + CA-084: Test cable for Vistacam IX HD with mini USB connector.</p> <p>Suspension PCB AO-348 : iX HD and HD Smart</p>

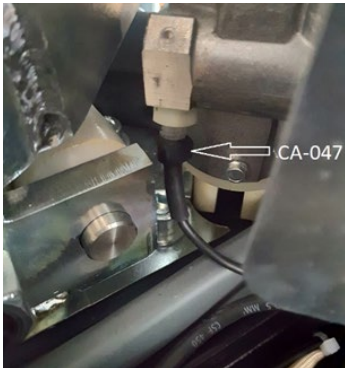
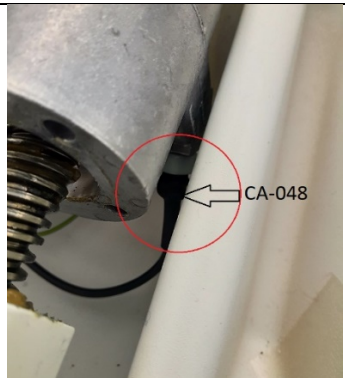
<p>The Hall sensor is defective.</p>	<p>Replace the Hall effect sensor, located in chair CA-048 connected to jumper J104 on AN-960. See picture and procedure down below</p>						
	<p>How to change the Hall sensor cable?</p>

<p>Same procedure for both cable CA-047 and CA-048</p> <p>Tighten the new Hall sensor until the sensor (not the lock nut) touches the magnet.</p> <p>Loosen the Hall effect sensor by ¼ turn</p> <p>Tighten the lock nut and make sure the sensor is properly fixed.</p> <div><p>J12 CHAIR SIGNAL LIFT</p><table><tr><td>1</td><td>CHAIR SIGNAL</td></tr><tr><td>2</td><td>+ 5V DC</td></tr><tr><td>3</td><td></td></tr></table></div>	1	CHAIR SIGNAL	2	+ 5V DC	3	
1	CHAIR SIGNAL							
2	+ 5V DC							
3								
<p>The backrest motor does not work</p>

<p>Replace the Hall Effect sensor, located in the CA-048 chair connected to the J104 jumper on AN-960.</p> <div><p>J104 HALL SIGNAL BACK REST</p><table><tr><td>1</td><td>HALL 1</td></tr><tr><td>2</td><td>+ 24V DC</td></tr><tr><td>3</td><td></td></tr></table></div>	1	HALL 1	2	+ 24V DC	3

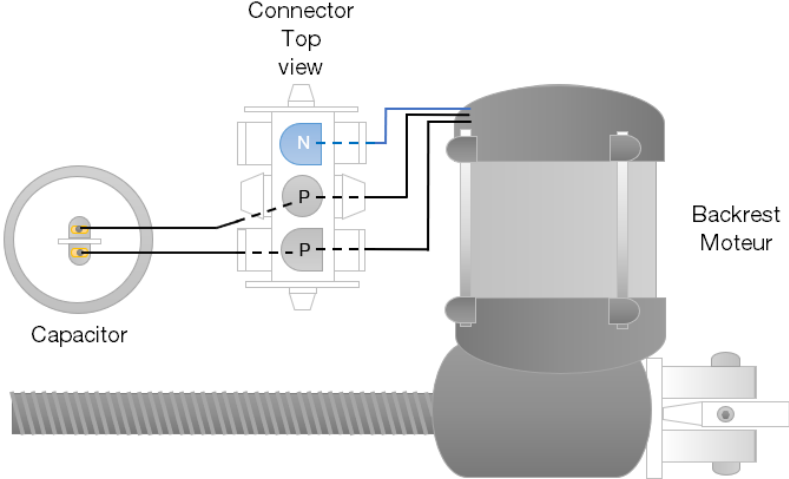
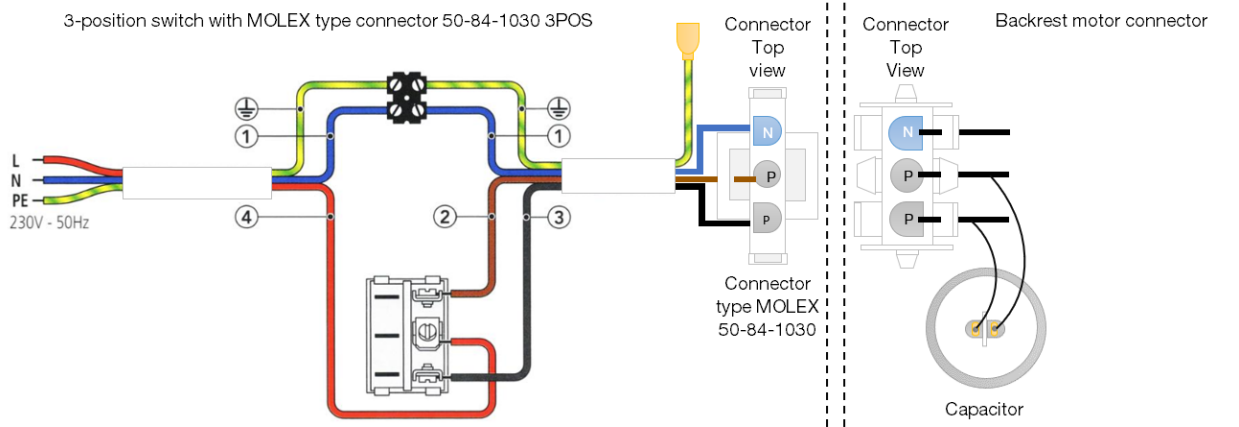
<div><div>Neutral</div><div>Lowering of Backrest motor</div><div>Raising of the backrest motor</div></div></div><div><div>Connector Top view</div>

<div>Capacitor</div><div>Backrest Moteur</div></div></div></div>

<p>3-position switch with MOLEX type connector 50-84-1030 3POS</p> <p>230V - 50Hz</p> <p>Connector Top view</p> <p>Connector type MOLEX 50-84-1030</p> <p>Backrest motor connector</p> <p>Capacitor</p>
Handling:	<p>Lower the backrest until it reaches its lowest position.</p> <p>Once lowered, disconnect the connector from the motor and plug the CA-002 cable connector.</p> <p>When done, turn on the power to the Unit.</p> <p>The motor will immediately start and raise the backrest.</p> <p>Immediately perform a synchronization before the chair locks</p> <p>See procedure on page 77.</p>

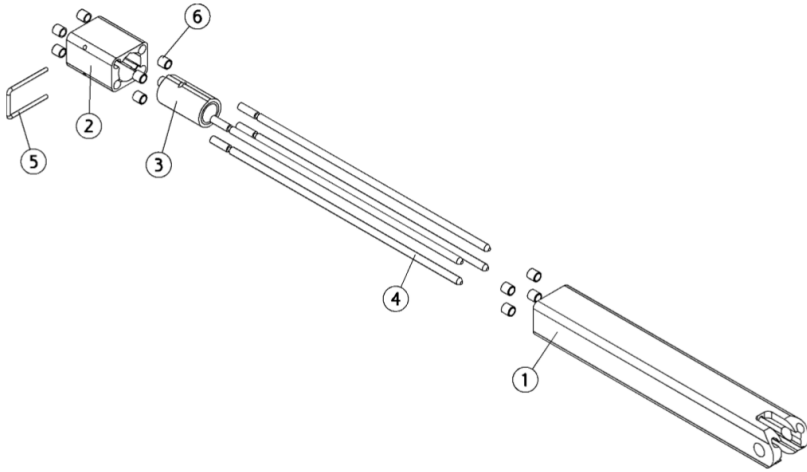
<p>Reassemble the 4 guiding rods correctly ④.</p> <p>Lock them ④ in the drive lock with U-shaped locking pin ⑤.</p> <p>Slide the backrest so that it rests on the lock nut. ②</p>
Powering up the Unit:	<p>When the backrest is correctly mounted, switch on the Unit, the motor will start and raise the backrest immediately.</p> <p>Enter the "technician's menu" by pressing C (configuration switch) twice without wasting time to perform a synchronization.</p>
Advice:	<p>To avoid too many tests, it is advisable to simulate several synchronization tests on the chair before switching on the motor.</p>
